CRACKING UP

LES WILLIAMS, DUNLOP CONVEYOR BELTING, THE NETHERLANDS, DISCUSSES THE EFFECTS OF OZONE ON RUBBER CONVEYOR BELTS.

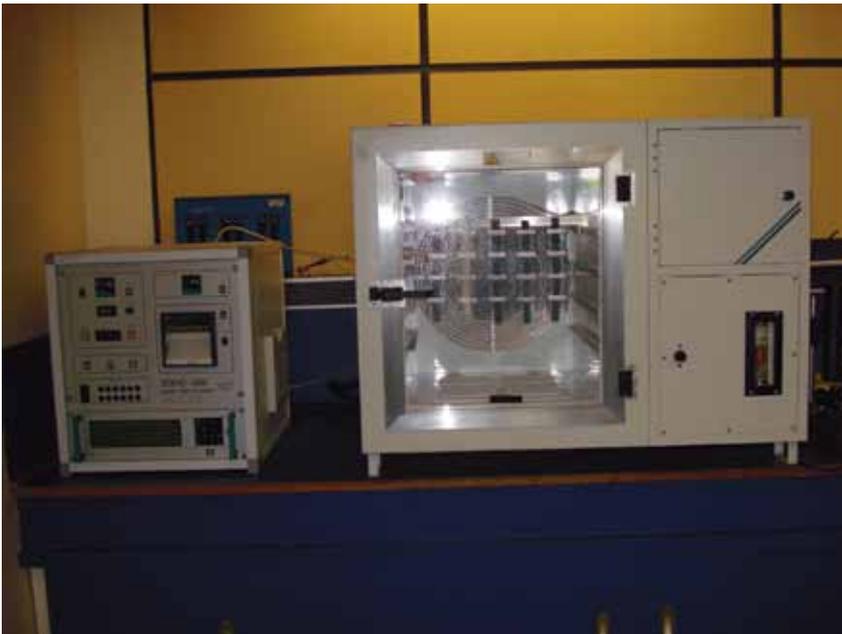
Dunlop's ozone testing cabinet.

Because of the growing importance of ozone resistance, Dunlop has invested in the latest, state-of-the-art testing equipment in their R&D laboratory. Mandatory testing to EN/ISO 1431 international standards using an ozone testing cabinet has been introduced for all Dunlop belting products and comparison tests also applied to samples of belts made by other manufacturers.

To scientifically measure resistance to ozone in accordance with EN/ISO 1431, samples are placed under tension (20% elongation) inside the ozone testing cabinet and exposed to highly concentrated levels of ozone for a period up to 96 hours. Every sample is closely examined for evidence of cracking at

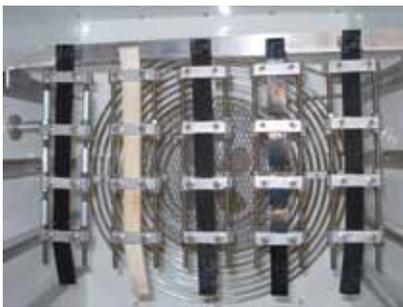
Samples under test.

two hourly intervals and the results carefully measured and recorded. Dunlop's technicians say that as a general rule, based on their experience, failure to exceed more than 8 hours under test without surface cracking will most likely correlate to less than 2 years in normal working conditions before the belt starts to deteriorate.

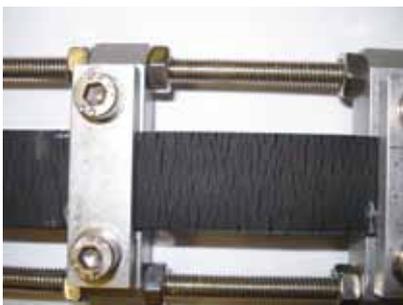
Competitor's belt sample showing surface cracking

To provide fair and accurate comparison data when testing samples of belts produced by competitors, the Dunlop technicians tested a number of samples from each manufacturer. These were often produced by different factories owned by the same company. In several cases the technicians found quite startling inconsistencies in the results, with some demonstrating high resistance to ozone exposure, while other samples from the same manufacturer showed minimal resistance.

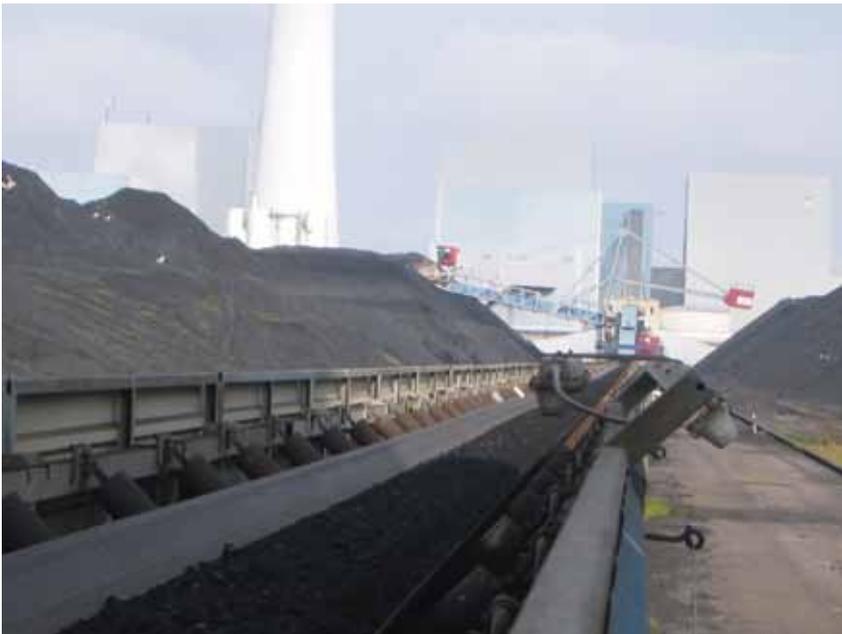
Environment issue? Coal dust can be shaken out from the underside of the belt.

Belts that do not operate under shelter are especially prone to surface cracking, which can have serious consequences in terms of the performance of the belt and its working life. There can also be significant environmental and health and safety consequences, especially in the coal industry because fine particles of coal dust penetrate the surface cracks, which are then discharged (shaken out) on the return (underside) run of the belt.
