WHAT'S THE CRAIC?

Have you ever wondered why some conveyor belts crack while others seem to wear until the canvas shows? Sometimes idle conveyors are hit worse than busy ones. We consulted Dunlop Conveyor belting in Holland to investigate why this happens and how to prevent it.

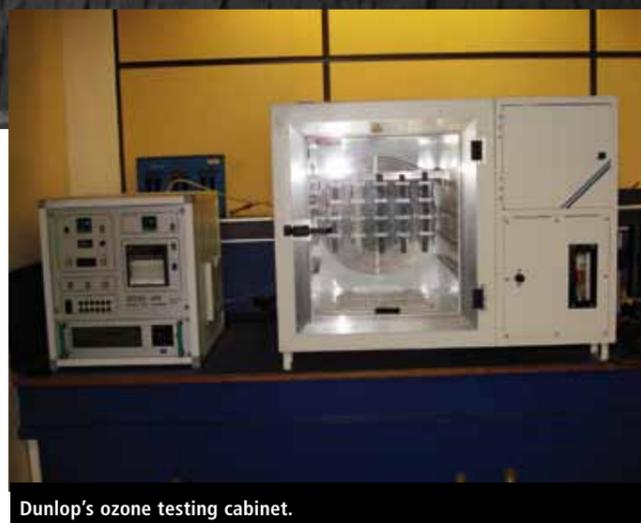
Dunlop's ozone testing cabinet.

Because of the growing importance of ozone resistance, Dunlop has invested in the latest, state-of-the-art testing equipment in their research and development laboratory. Mandatory testing to EN/ISO 1431 international standards using an ozone testing cabinet has been introduced for all

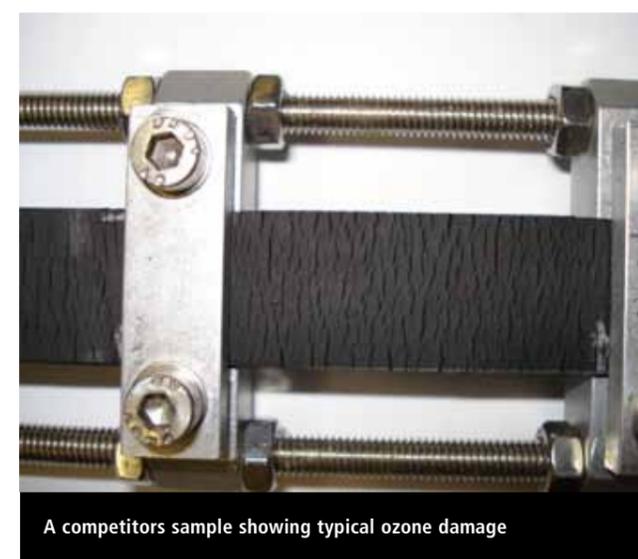
A competitors sample showing typical ozone damage

At first glance, fine cracks in the surface rubber may not seem to be a major problem but over a period of time the rubber becomes increasingly brittle. Transversal cracks deepen under the repeated stress of passing over the pulleys and drums and, if the conveyor has a relatively short transition distance, longitudinal cracks can also begin to appear. Again, surface cracking may not initially seem to be a cause of concern but there are often hidden long-term effects.

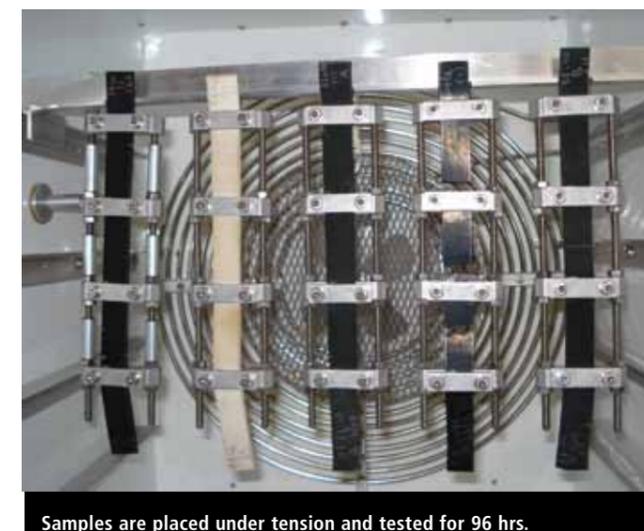
Samples are placed under tension and tested for 96 hrs.

To scientifically measure resistance to ozone in accordance with EN/ISO 1431, samples are placed under tension (20% elongation) inside the ozone testing cabinet and exposed to highly concentrated levels of ozone for a period up to 96 hours. Every sample is closely examined for evidence of cracking at two-hourly intervals and the results carefully measured and recorded. Dunlop's technicians say that as a general rule, based on their experience, failure to exceed more than 8 hours under test without surface cracking will most likely correlate to less than 2 years in normal working conditions before the belt starts to deteriorate.
