Too hot to handle?

The high temperatures experienced when transporting clinker in cement plants place special demands on conveyor belts and carcasses. To minimise costly repairs and plant shutdowns, a guide to selecting a heat-resistant conveyor belt is presented below, taking into account the key factors for consideration.

■ by **Dr Michiel Eijpe**, *Dunlop Conveyor Belting, The Netherlands*

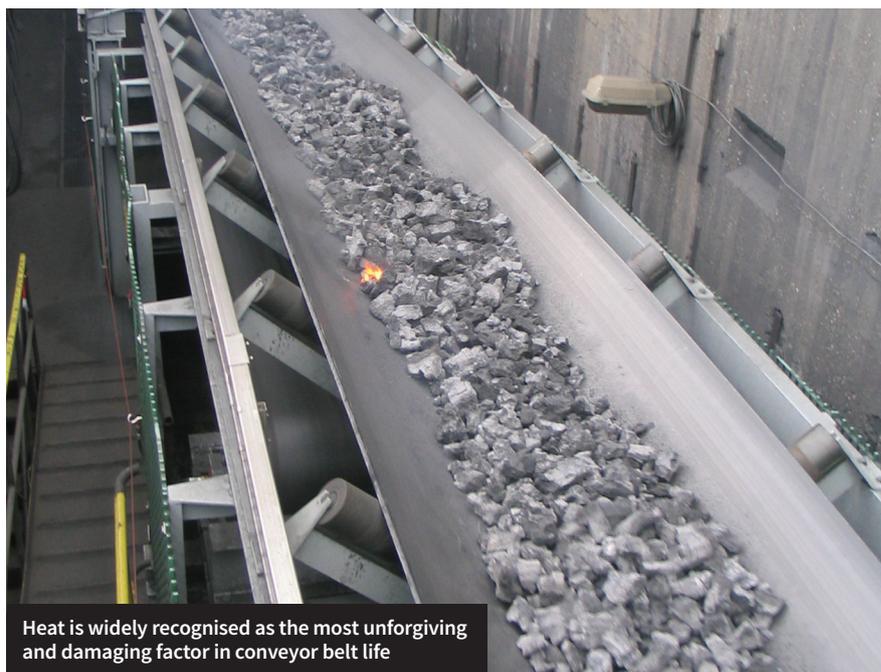
Heat is widely recognised as the most unforgiving and damaging factor in conveyor belt life

Of all the demands placed on conveyor belts operating in the cement industry, heat is widely regarded as the most unforgiving and damaging. High-temperature materials and working environments cause an accelerated aging process that results in a hardening and cracking of the rubber covers. Heat also has a very destructive effect on the carcass of the belt because it damages the adhesion between the covers on the top and bottom of the carcass, and also between the inner plies contained within the carcass. This is commonly referred to as 'delamination'.

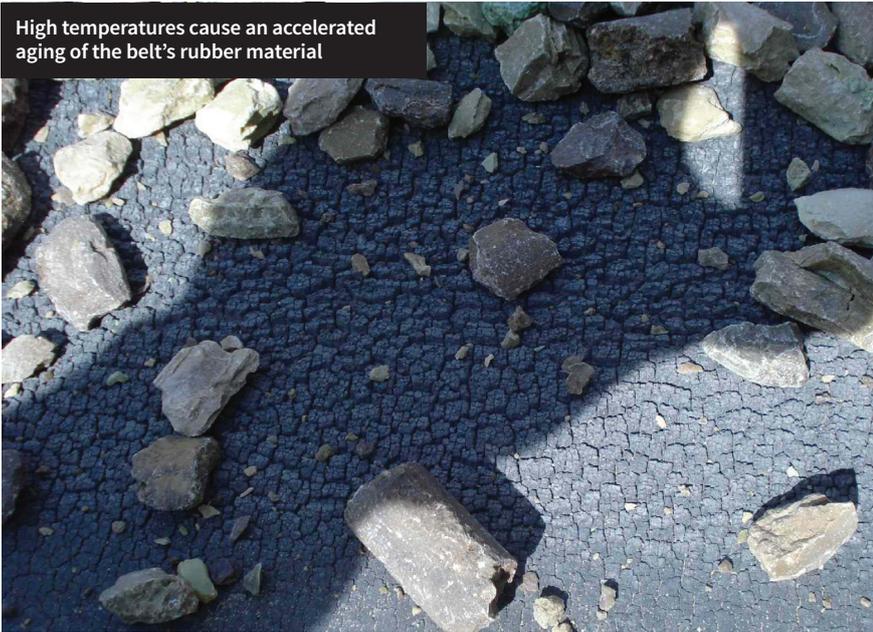
High temperatures cause an accelerated aging of the belt's rubber material

As rubber becomes harder and less elastic, the tensile strength and elongation (stretch) can fall by as much as 80 per cent, effectively destroying its overall operational strength and flexibility as well as seriously weakening the splice joints. At the same time, resistance to abrasion (wear) can decrease by 40 per cent or more.

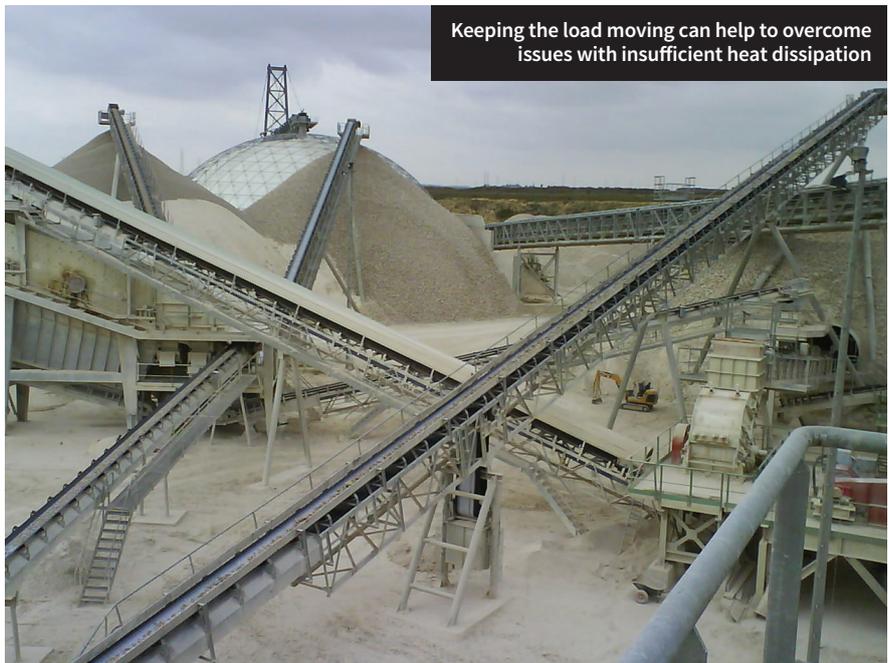
Keeping the load moving can help to overcome issues with insufficient heat dissipation

Apart from an insufficient resistance to heat, the most common cause of failure in heat-resistant belts is when a belt loaded with hot material is allowed to become static. This allows the heat to penetrate through to the carcass. Even the very best heat-resistant belts can easily be damaged beyond repair if a loaded conveyor is allowed to stop. Unless it is for emergency safety reasons, the loading feed to the conveyor should be stopped first and the belt allowed to fully discharge its load before being stopped. It is important to ensure that belts are not overloaded so that there is sufficient 'unloaded' room on either side of the belt surface to allow some of the heat to escape via the cooler outer edges.

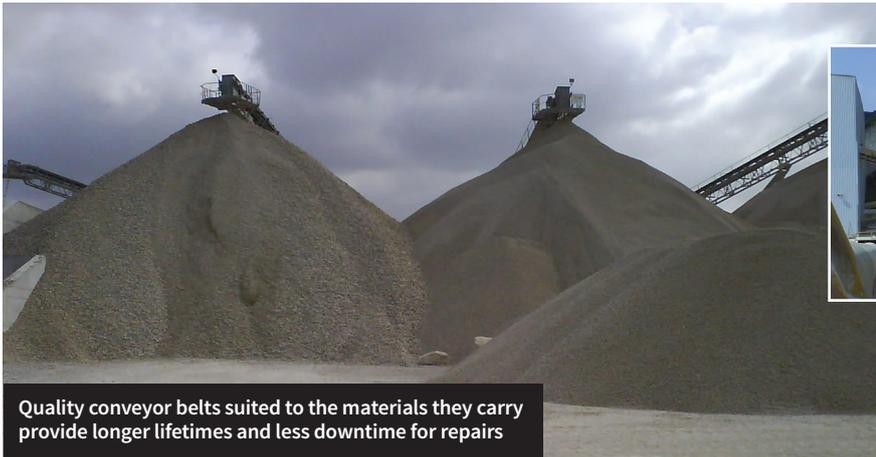
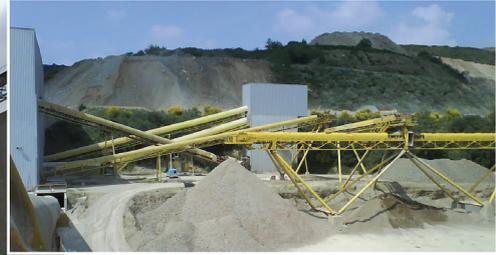
Hot clinker transport

To transport hot clinker, a cement plant in Spain had used heat-resistant belts from a number of different suppliers over the years but had found these belts only lasted about 4-5 months before they required replacement.

These very short average belt lifetimes resulted in considerable cost to the cement producer and a different solution was needed. Taking into consideration the characteristics of the clinker, which has a continuous material temperature of around 150 °C, Dunlop recommended 500/3 5+2 Deltahete.

The introduction of the Deltahete conveyor belt has considerably improved average conveyor belt life. Some 19 months after installation, the belt remains in good condition, lasting already more than three times than the previous belts.
