Operators waste millions every year on belts that wear out faster than they should

Millions of euros are being wasted by the aggregates industry every year because the conveyor belts they are using are wearing out much faster than they should be doing. The biggest single cause is that the rubber is of insufficient quality and provides inadequate resistance to the abrasive actions of the materials it is carrying. But there is more to it than that. Here, conveyor belt specialist Leslie David looks at the question of abrasion-resistant belting and provides some helpful advice on how to reduce costs by selecting belts that provide a much longer and cost-effective working lifetime.

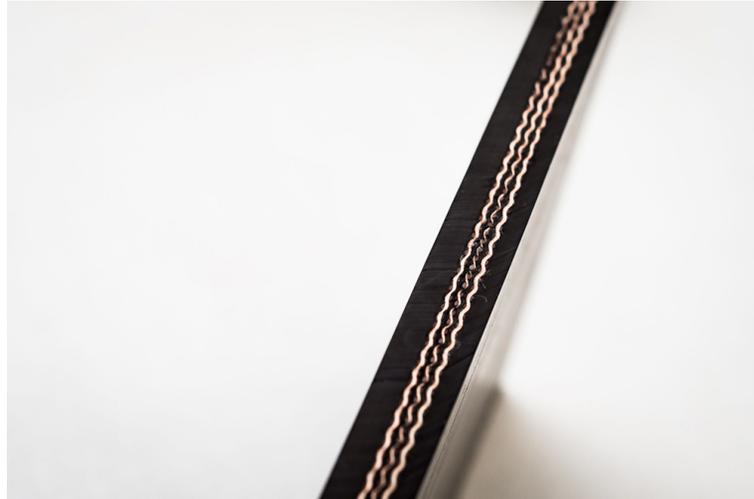
The wear-resistant quality of the covers is the biggest influence on the 'whole life' cost of a conveyor belt

The wear-resistant quality of the outer covers of a conveyor belt is the biggest single influence on the working life of the belt and consequently its 'whole life' economic cost. The rubber used for the outer covers usually constitutes at least 70% of the overall thickness of both multi-ply and steel cord belts. This makes the cost rubber the single biggest element of cost when manufacturing a conveyor belt. Consequently, it

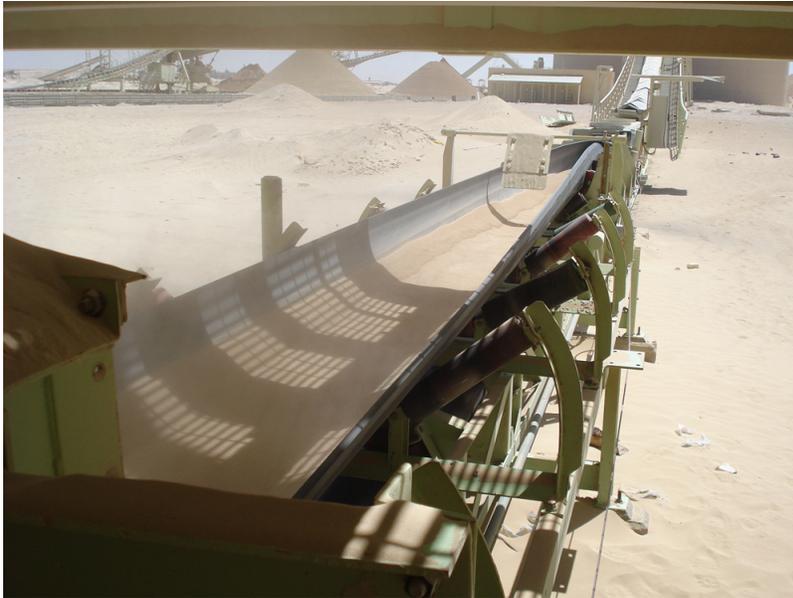
'Fine' act like a piece of coarse sandpaper that continually scours the rubber cover

It is a common misconception that a belt specified by a supplier as being 'abrasion resistant' should naturally be expected not to wear quickly. Different causes of wear and abrasion require different kinds of abrasion resistant covers. For example, belts that transport heavy and/or sharp objects such as rocks, timber or glass that cause cutting and gouging of the belt surface need different resistance properties compared to belts carrying 'fine' materials such as aggregate, sand and gravel, which literally act like a piece of coarse sandpaper that is constantly scouring the rubber cover.

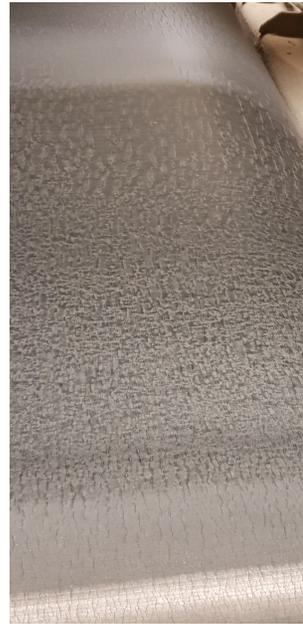
Always make ozone & UV resistance part of the specification when selecting any rubber conveyor belt

Rubber belts that are not fully resistant to ozone and UV can start to show signs of degradation even before they have been fitted to a conveyor simply by being exposed to the open air and daylight. Sadly, despite its crucial importance in terms of operational lifetime, ozone and UV resistance is very rarely, if ever, mentioned by traders or manufacturers. This is almost certainly because the anti-ozonants that need to be used during the mixing process of the rubber compounds are relatively costly. Building in that 'avoidable' cost would immediately make the belt less competitive on price. My advice is always to make ozone & UV resistance a required part of the specification when selecting any rubber conveyor belt.

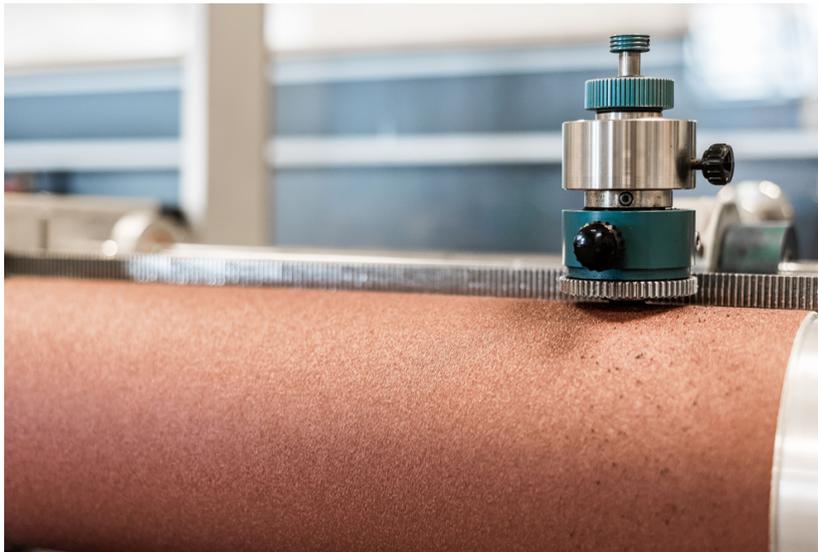
ISO 4649 / DIN 53516 abrasion testing. The lower the figure, the better the wear resistance

The test method for abrasion (ISO 4649 / DIN 53516) is actually quite simple. Abrasion resistance is measured by moving a test piece of rubber across the surface of an abrasive sheet mounted on a revolving drum. It is expressed as volume loss in cubic millimetres, for instance, 150 mm³. The most important thing to remember when

comparing abrasion test results (or promises!) is that higher figures represent a greater loss of surface rubber which means that there is a lower resistance to abrasion. Conversely, the lower the figure, the better the wear resistance.

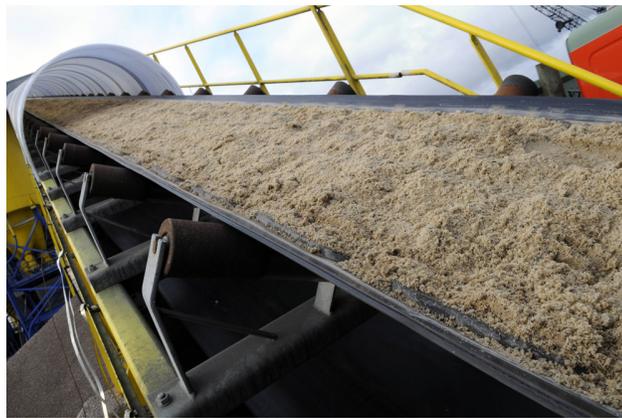
Fit one good quality belt – not two or three poor quality ones!

There is a lot more to conveyor belts than meets the eye. Fitting and replacing two or three 'economically priced' belts rather than opting for the longer operational lifetime provided by a single, good quality abrasion resistant belt is invariably a false economy and much more hassle in the long run!
