Bigger is not always better

When operators are experiencing problems with their conveyor belts, or even when they simply want to increase their operational lifetime, increasing the belt specification is often seen as the best way to solving the problem. More often than not, 'going bigger' by increasing the tensile strength, the number of plies or the thickness of the covers, has the opposite effect and actually makes matters even worse. Here, Dunlop Conveyor Belting's head of application engineering, Rob van Oijen, explains why bigger is not always better.

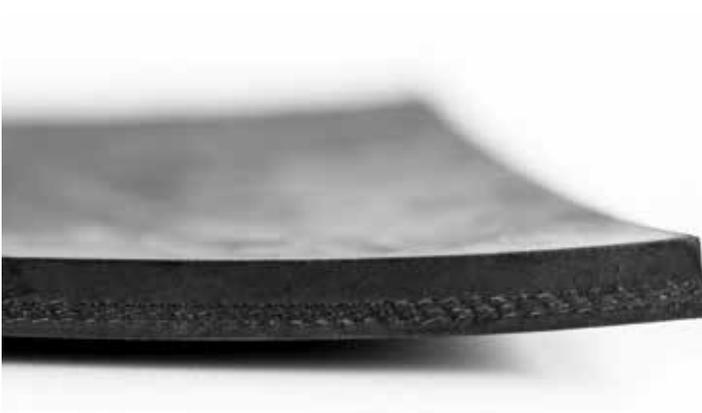
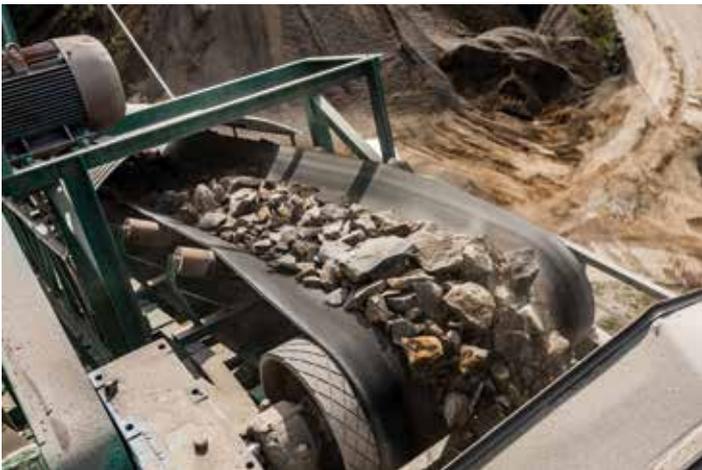
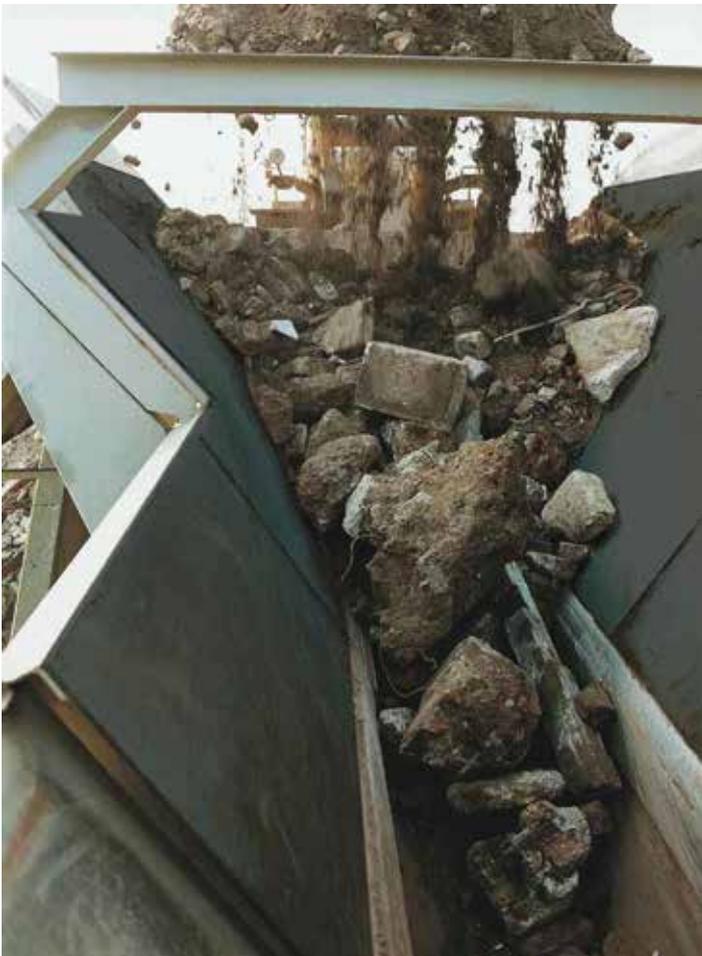
Not what they seem – The use of totally polyester (EE) plies rather than a combination of polyester and nylon.

The second reason for checking the true tensile strength of a belt before replacing it is that it is becoming increasingly common for some manufacturers, traders and importers to supply belts that have totally polyester (EE) fabric plies in a carcass that is declared as being an EP (polyester/nylon mix) carcass construction. The simple reason for this deception is that EE fabric costs some 30% less than EP fabric. In itself, this may not seem like a great deal but the fabric plies are a major cost component in any multiple ply conveyor belt so using the much cheaper polyester fabric is a big help when trying to achieve the perception of a lower 'like for like' price. The whole basis of using a mix of polyester and nylon fabric is that it has the best balance of mechanical properties including allowing a conveyor belt to run straight and true, to trough, to flex round pulleys and drums, stretch, transversal rigidity, longitudinal strength and much more besides.

The use of totally polyester (EE) fabric compromises a whole range of essential mechanical properties. The biggest danger is that a polyester weft can cause low transverse elasticity, which reduces both the troughability and impact resistance of the belt and also causes tracking issues. In addition, less weft in the belt can also reduce rip resistance, fastener strength and ability to handle small pulley sizes. The seriousness of the detrimental physical effects for the end-user are therefore huge. One test that I witnessed recently revealed that the tensile strength of the carcass was more than 20% lower than the specified minimum. To sum up, simply replacing a belt with one with a specified higher tensile strength and/or an increased number of plies is most often merely compensation for poor quality rather than a genuine and honest lack of (tensile) strength.
