The invisible enemy

HOW OZONE AND ULTRA VIOLET DRAMATICALLY SHORTENS THE WORKING LIFE OF CONVEYOR BELTS

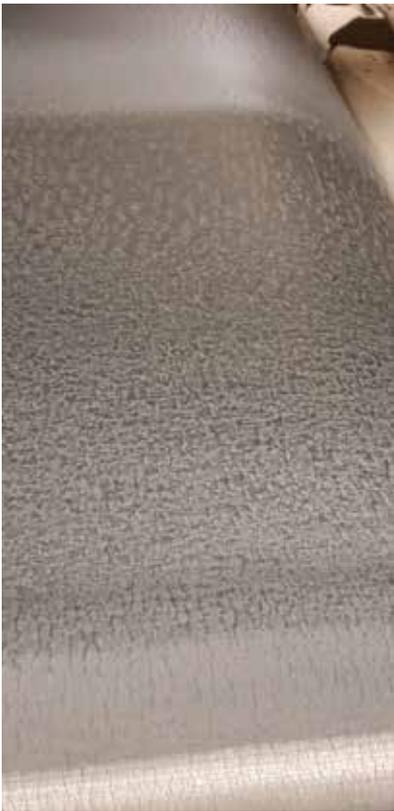
Ozonolysis is the reaction that occurs between the molecular structure (double bonds) and ozone:

Ozone cracks in the surface of the rubber.

The scientific explanation is that the immediate result is formation of an ozonide, which then decomposes rapidly so that the double bond molecule is split. The critical step in the breakdown of molecular chains is when polymers are attacked. The strength of polymers depends on the chain molecular weight or degree of polymerization. The longer the chain length, the greater the mechanical strengths including the highly important tensile strength of the rubber. By splitting the chain, the molecular weight drops rapidly. There comes a point when very little strength remains and cracks starts to form. Further attacks occur inside the freshly exposed cracks, which continue to grow steadily until they complete a 'circuit' and the product separates or fails.

Even tiny traces of ozone in the air will attack the molecular structure of rubber. It increases the acidity of carbon black surfaces with natural rubber, polybutadiene, styrene-butadiene rubber and nitrile rubber being the most sensitive to degradation. The first visible sign is when cracks start to appear in the surface of the rubber.

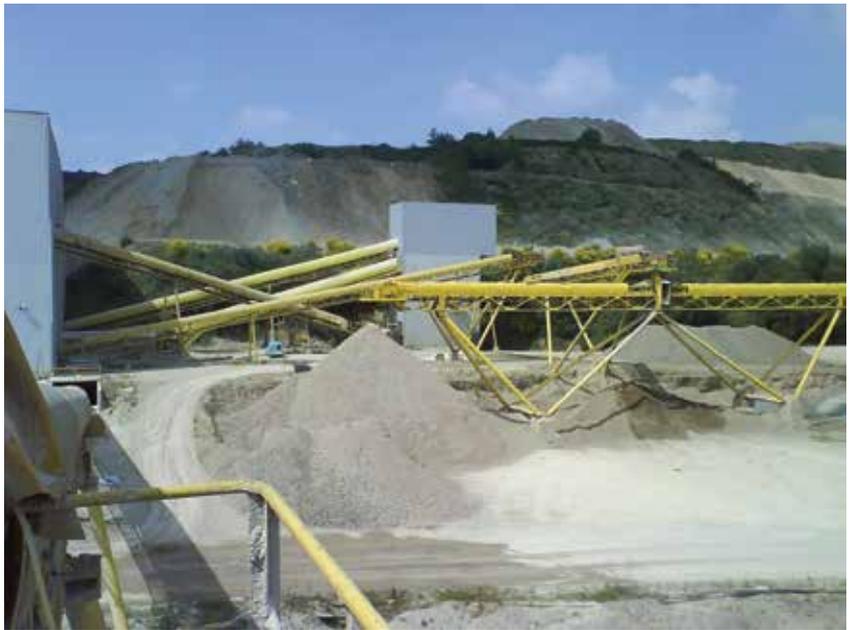
Foolish to underestimate the damage caused by UV exposure.

To make matters worse, 'bad' ozone has a partner in crime that also has a seriously detrimental effect on rubber. Ultraviolet light from sunlight and fluorescent lighting accelerates rubber deterioration because it produces photochemical reactions that promote the oxidation of the rubber surface resulting in a loss in mechanical strength. This is known as 'UV degradation'.

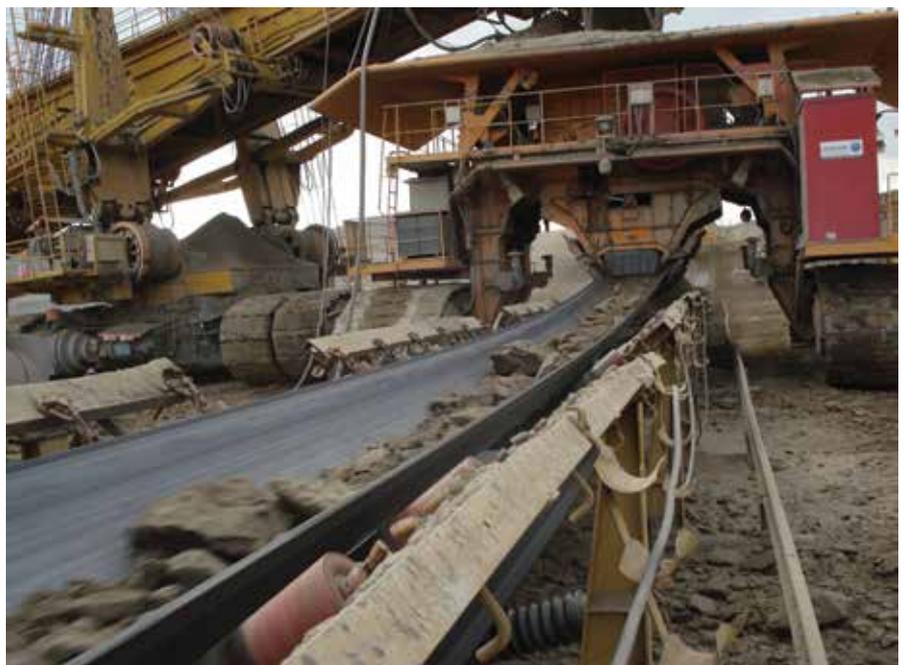
Transversal cracks deepen under the repeated stress of passing over the pulleys and drums.

At first glance, having small cracks in the surface rubber may not seem to be a big problem but over a period of time the rubber becomes increasingly brittle. As I have just mentioned, transversal cracks deepen under the repeated stress of passing over the pulleys and drums. The ozone continues to attack so the cracks will steadily grow until catastrophic failure occurs. Cracks often present other potential risks such as scrapers catching on them and tearing off parts of the cover. Re-splicing can also become increasingly difficult over time as the adhesion properties of the rubber diminish.

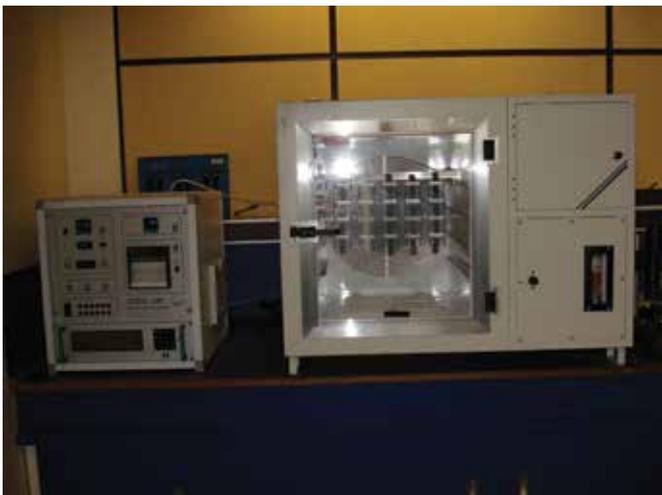
Dunlop's ozone testing cabinet.

To scientifically measure resistance to ozone in accordance with the EN/ISO 1431 test method, samples are placed under tension (eg. 20% elongation) inside an ozone testing cabinet and exposed to highly concentrated levels of ozone for a period of up to 96 hours (@ 40°C, 50 pphm and 20% strain).

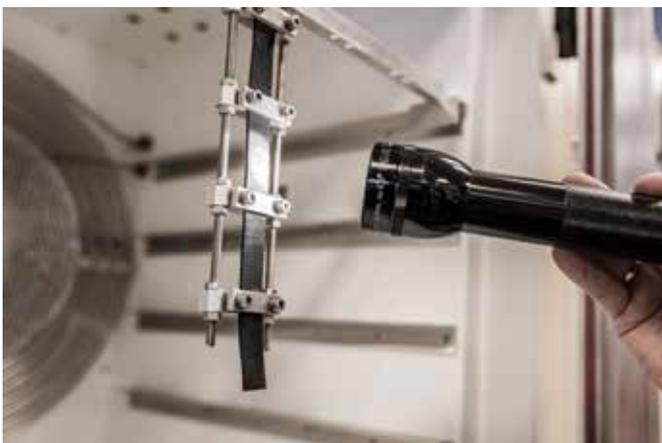
Samples are checked for cracking at two-hourly intervals.

Samples are closely examined for evidence of cracking at two-hourly intervals and the results carefully measured and recorded. Experience has determined that in order for the rubber to be regarded as adequately resistant, the pass criteria needs to be that the rubber sample does not show any signs of cracking within the 96-hour period.

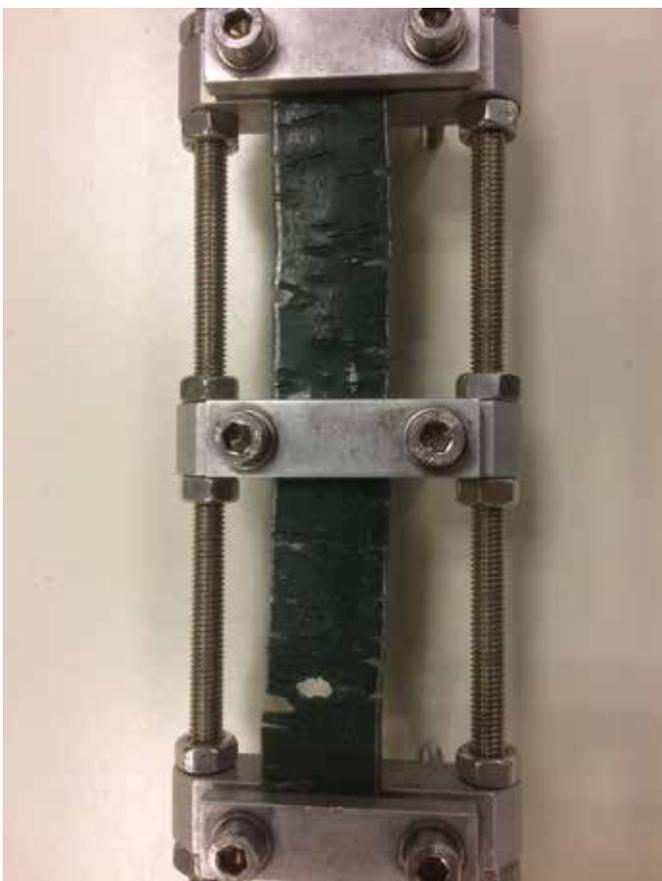
Some rubber literally disintegrates.

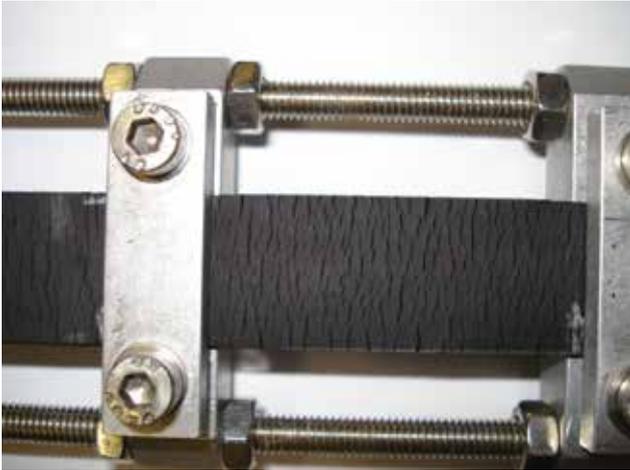
Ground level ozone seriously damages rubber
