The top five reasons why conveyor belts have to be replaced prematurely.

Although industrial conveyor belts are costly components, it is increasingly common to see belts being replaced much sooner than they really should be. Here, conveyor belt specialist Leslie David explains the top five reasons for the lack of longevity as well as providing some helpful tips on how to maximise belt life and reduce costs.

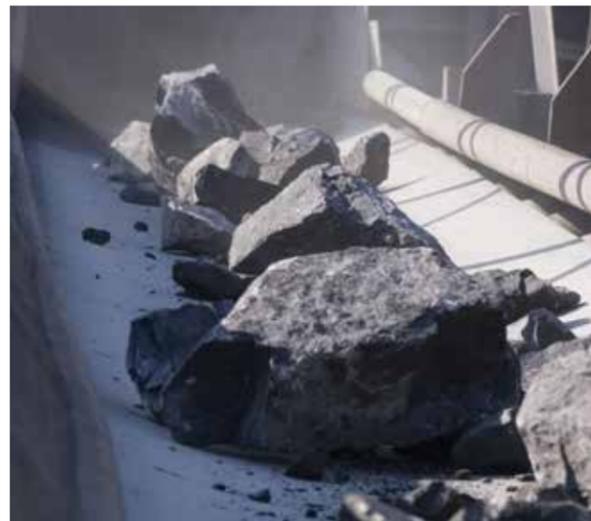
The materials being conveyed are important to correct belt selection

Whatever the case, selecting a conveyor belt involves making a complicated assessment of all available parameters such as the conveyor system itself including pulley diameters, transition distances, transverse rigidity and much more. Just as importantly, the materials to be conveyed, operational environments and health & safety considerations all have to be taken into account.

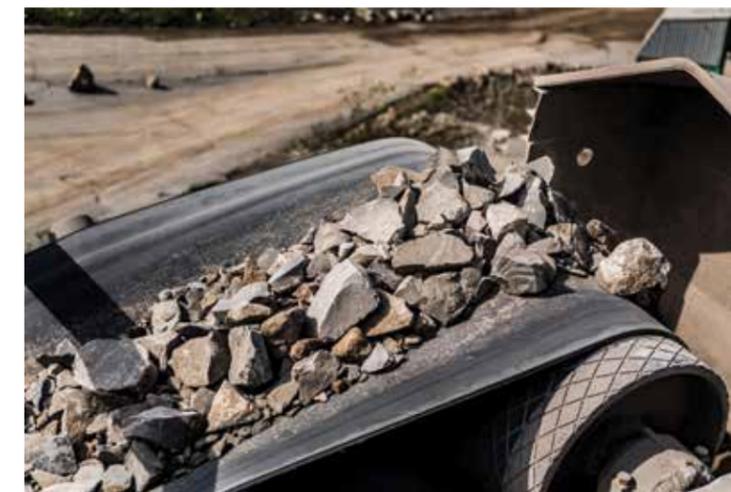
Different causes of wear and abrasion require different kinds of abrasion resistant rubber.

Different causes of wear and abrasion require different kinds of abrasion resistant rubber. For example, belts that transport heavy and/or sharp objects such as rocks, which cut and gouge the belt surface need different resistance properties compared to belts carrying 'fine' materials such as aggregate, sand and gravel, which literally act like a piece of coarse sandpaper that is constantly scouring the belt surface.

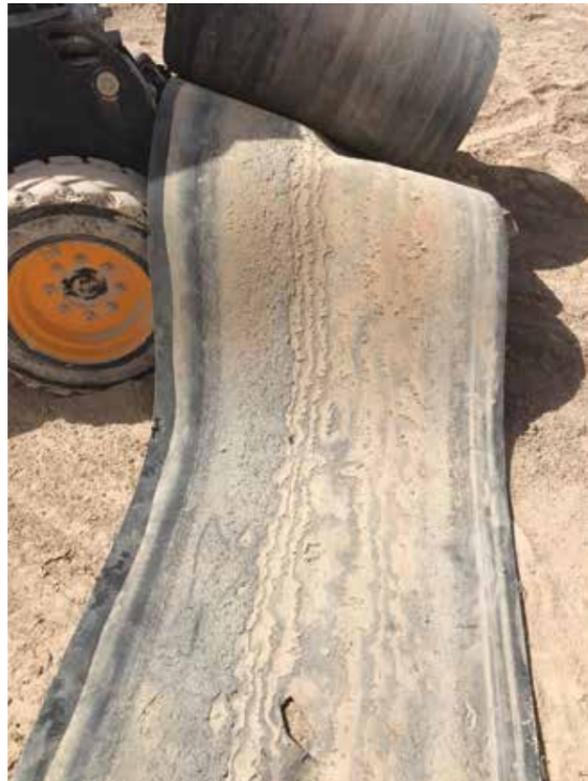
Ozone & ultra violet light causes rubber to literally disintegrate.

A final word on wear resistance – whatever cover grade you use, it is absolutely essential that the rubber is fully resistant to the effects of ozone and ultra violet. At ground/sea level ozone becomes a pollutant. Exposure is unavoidable. It increases the acidity of carbon black surfaces and causes reactions to take place within the molecular structure of the rubber resulting in surface cracking and a marked decrease in its tensile strength.

Likewise, ultraviolet light from sunlight and artificial (fluorescent) lighting also accelerates deterioration because it produces photochemical reactions that promote the oxidation of the surface of the rubber resulting in a loss in mechanical strength. In both cases, this kind of degradation causes the covers of the belt to wear out even faster than they should. In my experience, belts imported from South East Asia will almost certainly not be resistant to ozone and UV. My advice is therefore to make ozone & UV resistance an essential part of the specification when selecting any rubber conveyor belt.

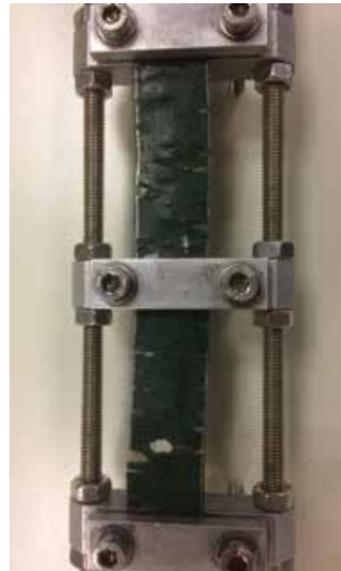
The wear resistance of rubber is a combination of overall strength, resistance to abrasion and resistance to cut and tear propagation.

It is also important to bear in mind that the ability of a belt cover to withstand wear is not due to its 'abrasion resistance' alone. The wear resistance of rubber is a combination of its overall strength, its resistance to abrasion and its resistance to cut and tear propagation. If the latter is very low then a small, seemingly insignificant area of damage in the cover can easily increase due to the continuous material loading and the relentless flexing of the rubber around the drums and pulleys. In time, this damage will connect to another area of damage and consequently a small piece of damaged rubber will effectively be cut out and lost rather than simply worn off.

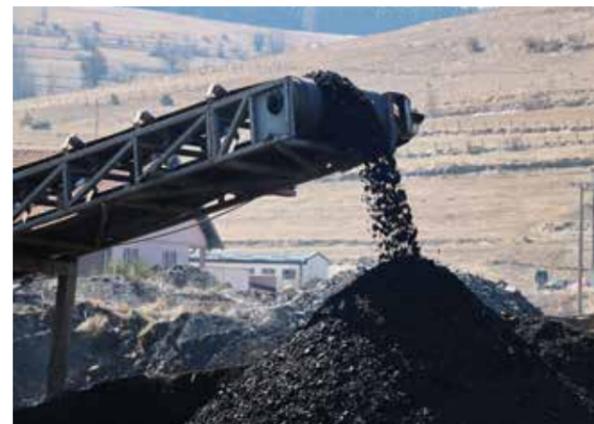
Even the strongest belts can be ripped, torn or punctured by sharp foreign objects.

As every site manager will know, when foreign objects become trapped, penetrate the carcass and cause longitudinal ripping, even the strongest, heaviest belts can be quickly destroyed. The same applies when a belt is torn or the carcass is punctured by heavy, sharp materials falling from height. It is something that all conveyor operators have to contend with. Believing that such damage is unavoidable and trying to save money by fitting low grade 'sacrificial' belts is certainly not the answer. Using 'throwaway' belts is a false economy and simply does not make economic sense, especially when you calculate the cost of frequent repairs and total belt replacement plus the cost of downtime while that work has to be carried out.

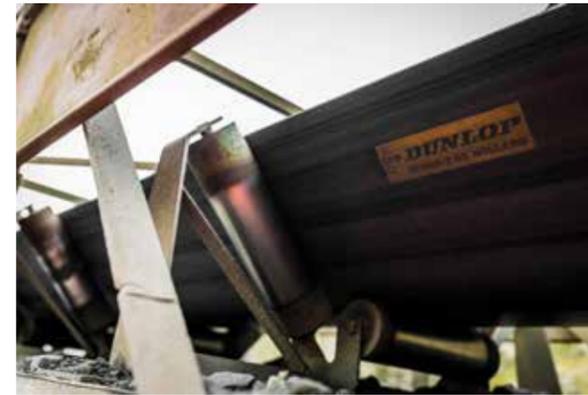
Ripping, tearing and impact – the best solution is to fit a conveyor belt specifically engineered for the purpose.

Because of the huge disparities between the types of materials being conveyed, the actual design of the conveyor systems and their varied working environments, there is no 'silver bullet' answer to the rip, tear and impact damage. For multi-ply belts the only genuinely practical solution is to fit a conveyor belt that has been specifically engineered to resist ripping and tearing and cope with the impact of heavy objects such as large rocks falling from a high drop height much more effectively compared to belts that use a conventional fabric ply construction. Specially woven fabric plies that allow the transversal nylon strands to stretch are used to create a much greater level of resistance. As the trapped object is pulled through the belt, the transversal (weft) strands of the fabric group together into a bundle that can eventually become strong enough to stop the belt. Strange as it may seem, these special synthetic plies are usually more effective than steel when it comes to actually minimising the length of a rip. Another important feature of such specialist fabrics is the ability to absorb punishment caused by heavy impact by dissipating the energy over a wider area compared to conventional fabric.

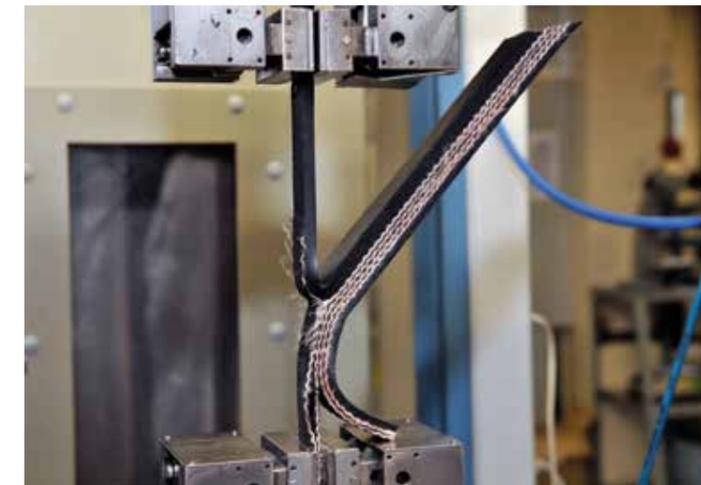
It is a good idea to have a piece of spare belt laboratory tested to measure its true properties.

As I mentioned earlier, simply increasing the tensile strength or the number of plies can cause more problems than it solves. I would strongly advise getting a completely new belt calculation using a professional belt calculation program before you consider any change of belt specification. If you have a piece of spare belt available then it is often a good idea to send a square meter of it for laboratory testing to measure its true tensile strength.

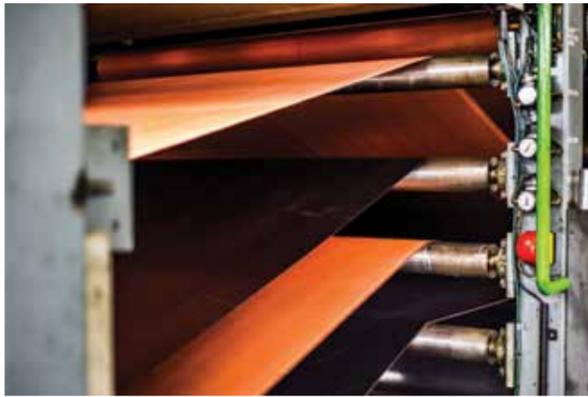
Not what they seem – some belts are supplied totally polyester (EE) fabric plies in a carcass declared as being an EP (polyester/nylon) carcass.

The second reason for checking the true tensile strength of a belt before replacing it is that it is becoming increasingly common for some manufacturers, traders and importers to supply belts that have totally polyester (EE) fabric plies in a carcass that is declared as being an EP (polyester/nylon mix) carcass construction. The simple reason for this deception is

that EE fabric costs some 30% less than EP fabric. In itself, this may not seem like a great deal but the fabric plies are a major cost component in any multiple ply conveyor belt so using the much cheaper polyester fabric is a big help when trying to achieve the perception of a lower 'like for like' price.

The whole basis of using a mix of polyester and nylon fabric is that it has the best balance of mechanical properties including allowing a conveyor belt to run straight and true, to trough, to flex round pulleys and drums, stretch, transversal rigidity, longitudinal strength and much more besides. The use of totally polyester (EE) fabric compromises a whole range of essential mechanical properties*. The biggest danger is that a polyester weft can cause low transverse elasticity, which reduces both the troughability and impact resistance of the belt and also causes tracking issues.

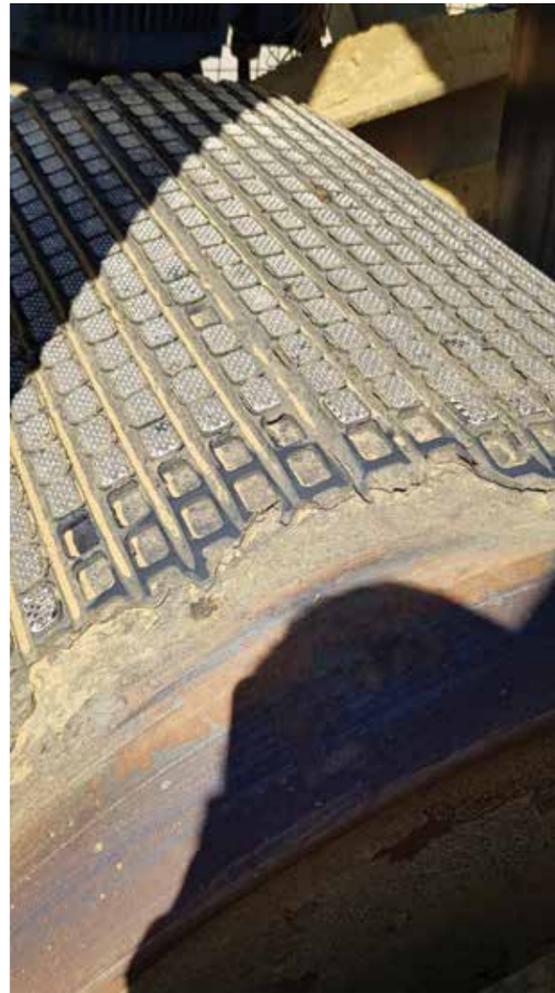
Identifying and fixing problems early will save on more costly repairs later.

The whole question of conveyor maintenance is a subject in its own right. However, as simple as it might sound, a daily visual inspection of all the idlers, rollers, pulleys and drums is time well spent. Identifying and fixing problems at an early stage will certainly save on more costly repairs and maintenance later and with far less downtime. It will also help to keep your conveyors operating smoothly and your conveyor belts running trouble-free for periods that are much longer than you might ever have thought possible.
