## Keeping coal on the move – in the stockyard and elsewhere

**C**onveyor belt specialist Leslie David explains how belts that last up to three or four times the norm can dramatically reduce the cost of conveying coal.

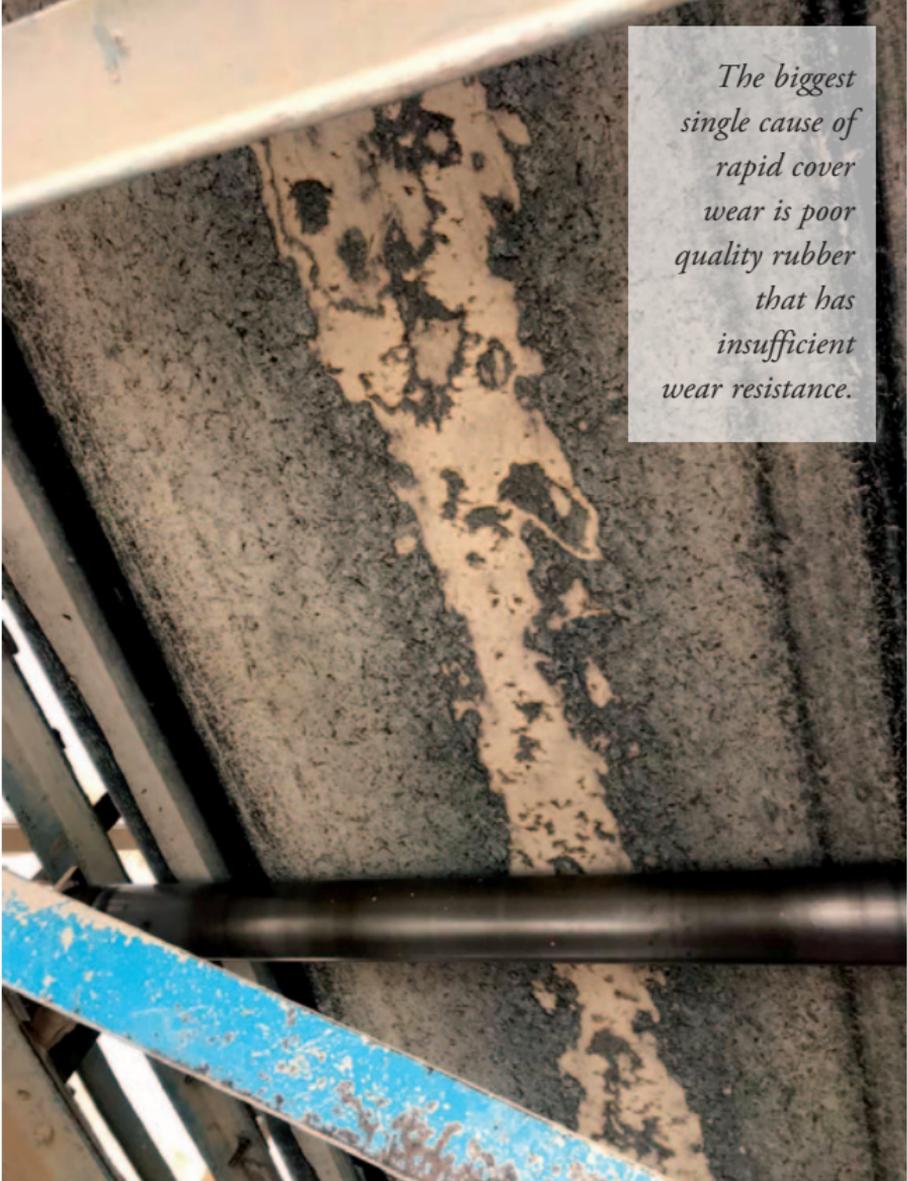
*The biggest single cause of rapid cover wear is poor quality rubber that has insufficient wear resistance.*

Wear and tear takes place over time but the actual length of time mostly depends on the durability of the belt covers. The biggest cause of rapid belt cover wear is simply because the manufacturer has used low-grade rubber that has an inadequate resistance to wear. Put another way, the rubber compound has been produced with ‘economy’ (low selling price) as the first priority rather than using a formula engineered to provide a high level of wear resistance and longer operational lifetime. In a typical belt, rubber constitutes at least 70% of the material mass so it is the prime target for cost cutting.
