# TECHNICAL INFORMATION BULLETIN ABRASION RESISTANT BELTING

## INCREASING THE WORKING LIFE OF YOUR CONVEYOR BELTS

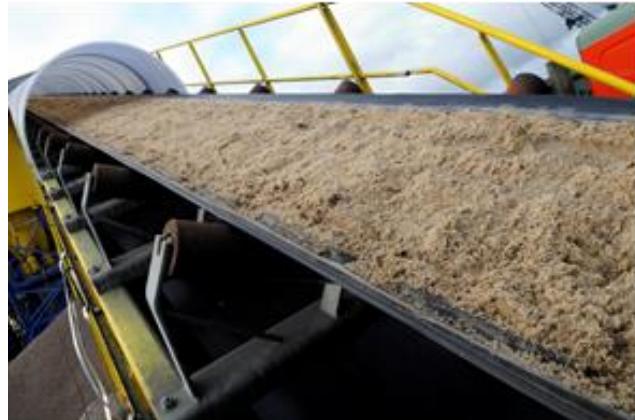
Misaligned drums and idlers cause extra wear

Wear on the bottom cover of the belt is mainly caused by the friction contact with the drum surface and idlers. The rate and uniformity of this type of wear can be adversely affected by many other factors such as misaligned or worn drums and idlers set at incorrect angles. Factors such as ozone degradation (cracking) or an unclean environment where there is a build up of waste material can accelerate wear. Belt cleaning systems, especially steel edged scrapers, can also cause wear to the top cover surface.

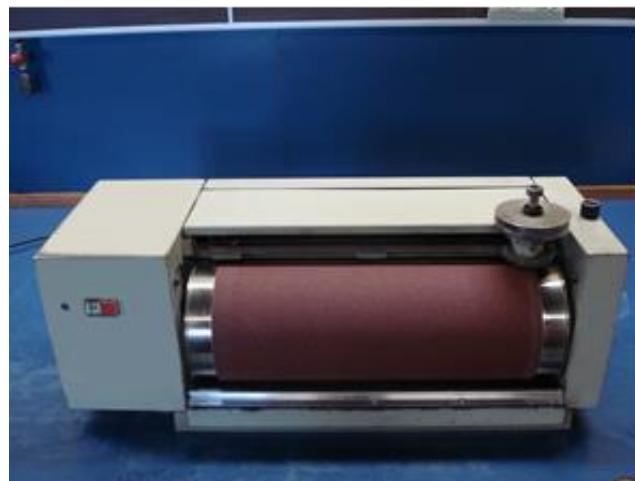
ISO /DIN Abrasion testing machine at Dunlop lab
