TECHNICAL INFORMATION BULLETIN

ABRASION RESISTANT BELTING

INCREASING THE WORKING LIFE OF YOUR CONVEYOR BELTS

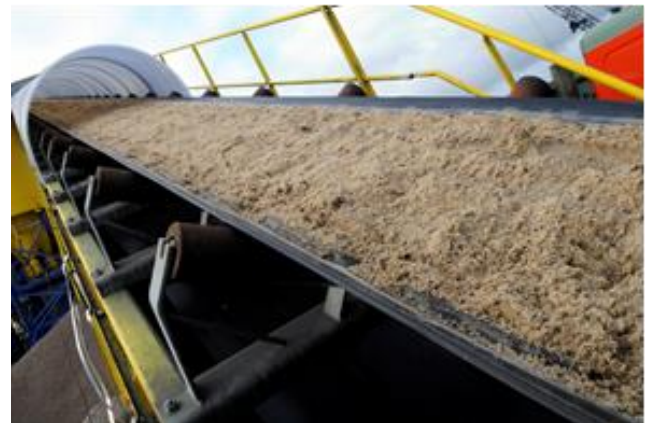
Misaligned drums and idlers cause extra wear

Wear on the bottom cover of the belt is mainly caused by the friction contact with the drum surface and idlers. The rate and uniformity of this type of wear can be adversely affected by many other factors such as misaligned or worn drums and idlers set at incorrect angles. Factors such as ozone degradation (cracking) or an unclean environment where there is a build up of waste material can accelerate wear. Belt cleaning systems, especially steel edged scrapers, can also cause wear to the top cover surface.

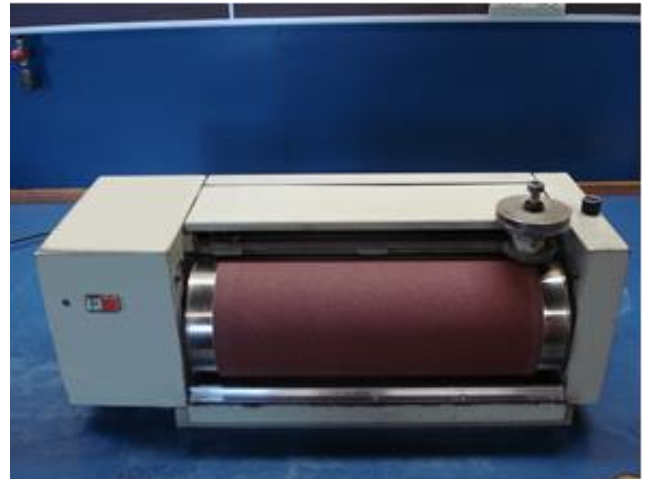
ISO /DIN Abrasion testing machine.

There are two internationally recognised sets of standards for abrasion, ISO 10247 (H, D and L) and the longer-established DIN 22102 (Y, W and X) standards. In general terms, DIN Y relates to 'normal' service conditions; DIN W for more abrasive materials and DIN X for resistance to cutting, impact (from high drop heights), abrasion and gouging resulting from large lump sizes of heavy and sharp materials.
