TECHNICAL ARTICLES

WEARING THIN – CAUSES AND SOLUTIONS FOR CONVEYOR BELTS THAT HAVE TO BE REPLACED PREMATURELY DUE TO SURFACE WEAR

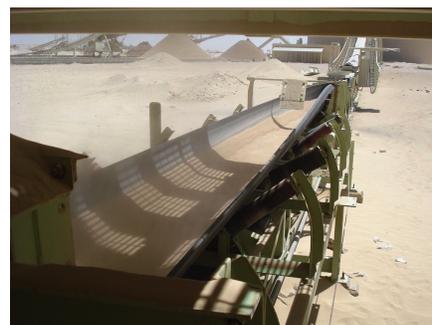
Fine materials act like sandpaper on the rubber surface

It is a common misconception that a belt specified by a supplier as being 'abrasion resistant' should naturally be expected not to wear quickly. Different causes of wear and abrasion require different kinds of abrasion resistant covers. For example, belts that transport heavy and/or sharp objects such as rocks, timber or glass that cause cutting and gouging of the belt surface need different resistance properties compared to belts carrying 'fine' materials such as aggregate, sand and gravel, which literally act like a piece of coarse sandpaper that is constantly scouring the rubber cover.

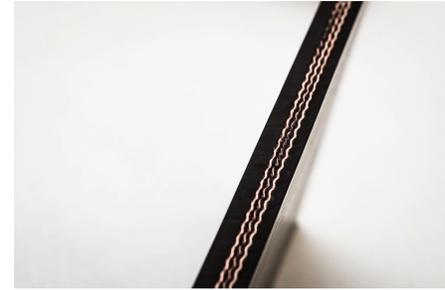
Abrasion resistance is more important than thickness

The actual thickness of the cover is an important consideration. Generally speaking, the more abrasive the material and the shorter the conveyor, the thicker the cover should be. In principle, the difference in thickness between the top cover and the bottom cover should not exceed a ratio of more than 3 to 1. In an effort to extend operational lifetime, many conveyor belt users resort to fitting belts with increasingly thicker covers. However, covers that are too thick can potentially cause other problems. In reality, the single most important factor is the actual abrasion resistance of the belt cover rubber.

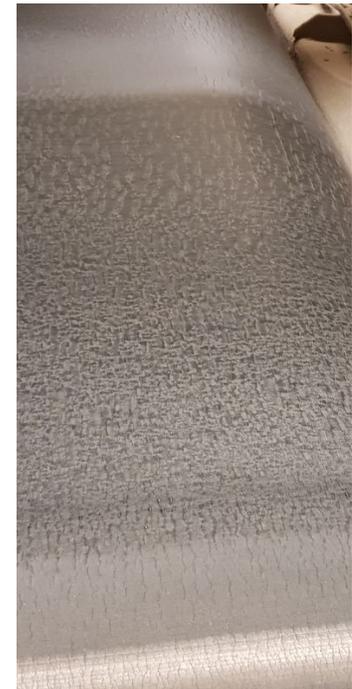
Close up of ozone cracked belt

There is absolutely no question that ALL rubber conveyor belts should be fully resistant to the damaging effects of ozone and ultra violet light. This is because ozone becomes a pollutant at ground level. Exposure increases the acidity of carbon black surfaces and causes reactions to take place within the molecular structure of the rubber. This has several consequences such as surface cracking and a marked decrease in the tensile strength of the rubber. Likewise, ultraviolet light from sunlight and artificial (fluorescent) lighting also accelerates deterioration. This is because it produces photochemical reactions that promote the oxidation of the surface of the rubber resulting in a loss in mechanical strength. In both cases, this kind of degradation causes the covers of the belt to wear out even faster than it should.

Rubber belts that are not fully resistant to ozone and UV can start to show signs of degradation even before they have been fitted to a conveyor simply by being exposed to the open air and daylight. Sadly, despite its crucial importance in terms of operational lifetime, ozone and UV resistance is very rarely, if ever, mentioned by traders or manufacturers. This is almost certainly because the anti-ozonants that need to be used during the mixing process of the rubber compounds are relatively costly. Building that 'avoidable' cost in would immediately make the belt less competitive on price. My advice is to always make ozone & UV resistance a required part of the specification when selecting any rubber conveyor belt.

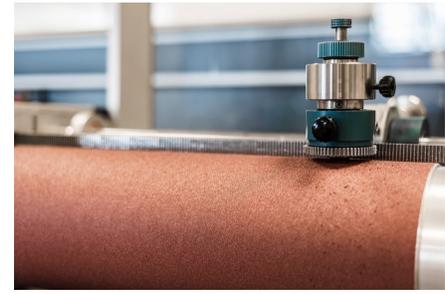
ISO 4649 / DIN 53516 abrasion testing

The test method for abrasion (ISO 4649 / DIN 53516) is actually quite simple. Abrasion resistance is measured by moving a test piece of rubber across the surface of an abrasive sheet mounted on a revolving drum. It is expressed as volume loss in cubic millimeters, for instance 150 mm³. The most important thing to remember when comparing abrasion test results (or promises!) is that higher figures represent a greater loss of surface rubber which means that there is a lower resistance to abrasion. Conversely, the lower the figure the better the wear resistance.

There are two internationally recognised sets of standards for abrasion, EN ISO 14890 (H, D and L) and DIN 22102 (Y, W and X). In Europe it is the longer-established DIN standards that are most commonly used. Generally speaking, DIN Y (ISO 14890 L) relates to 'normal' service conditions. In addition to resisting abrasive wear DIN X (ISO 14890 H) also has good resistance to cutting, impact and gouging. DIN W (ISO 14890 D) is usually reserved for particularly high levels of abrasive wear.
